# Structural engineering Report

415 Old Mill Rd, Towson, MD 21204

| CLIENT<br>Old Mill Partners LLC | INSPECTION DATE<br>August 13, 2026 | WEATHER<br>Dry, 79°F |

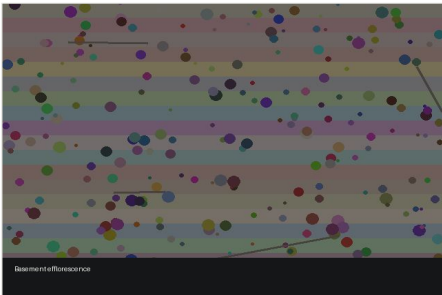
*Basement, east wall*

Efflorescence and dampness accompany the cracking; exterior downspout discharges at the affected wall.

Efflorescence at crack line

**Recommendation:** Correct exterior drainage concurrent with structural repair.

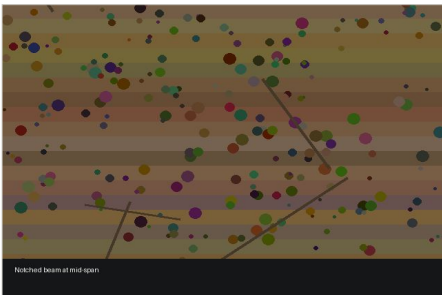
*First floor, center*

A 6x8 built-up girder was notched approximately 2-1/2 inches deep at mid-span for a plumbing line, reducing its effective section; corresponding floor slope of 3/4 inch over 10 feet was measured above.

Notched girder at mid-span

**Recommendation:** Sister or replace the girder per engineered detail; jack and re-level under engineering direction.
